Manhole Inspection Summary

Manhole # S69U__006MH

Location Address: **1820 Portal St.**

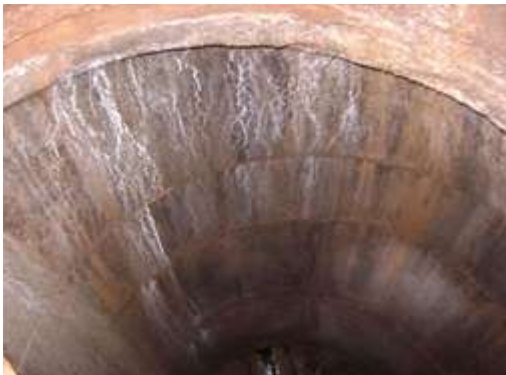
Defect 3

INFILTRATION

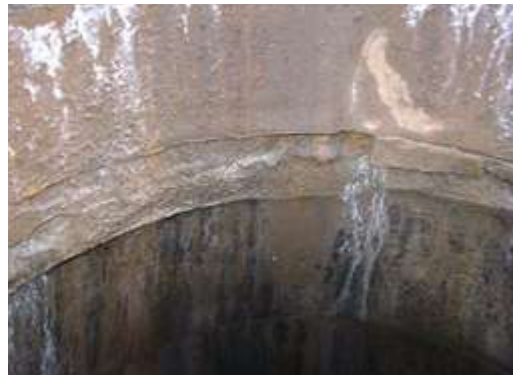
Defect 4

DETERIORATION

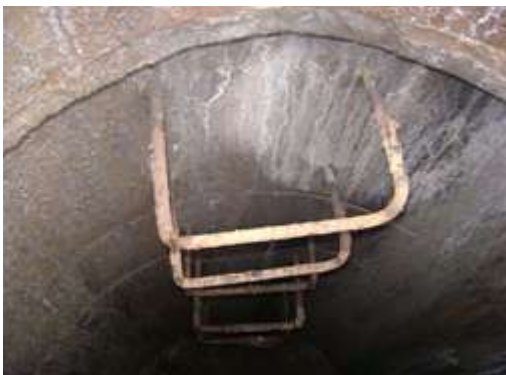
Defect 2

DETERIORATION of steps
chimney/frame.

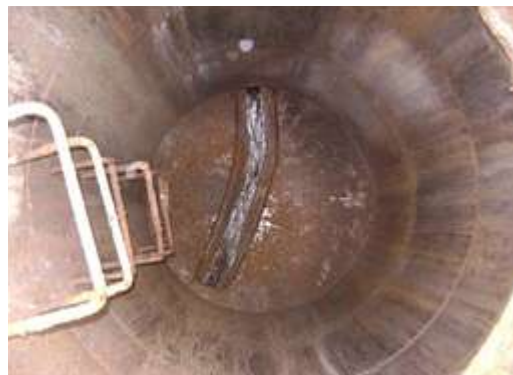
Defect 1

INFILTRATION

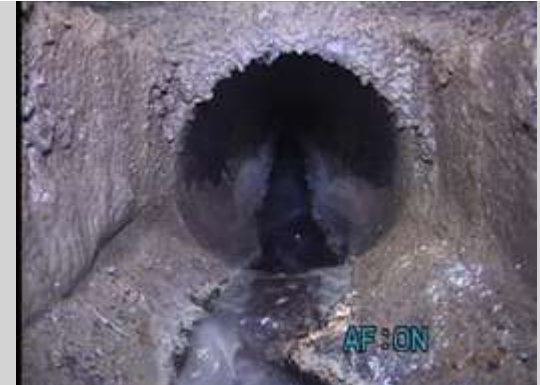
12 O'Clock Outflow

8 in. Circular Gravity Sewer
Pipe Out @ 12 O'Clock

Pipe Height: **8.4** (in.) Rod and Bar (Angled)
Pipe Material: **Clay** ☐ Pipe Lined
Invert Depth: **8.92** (ft.) Flow Characteristics: **Slow**
Deposits: ☒ None ☐ Mud ☐ Sludge ☐ Debris ☐ Grease
Silt Depth: (in.) Deposits Extent:
Infiltration: **None** Pipe Seal Cond: **Sound**

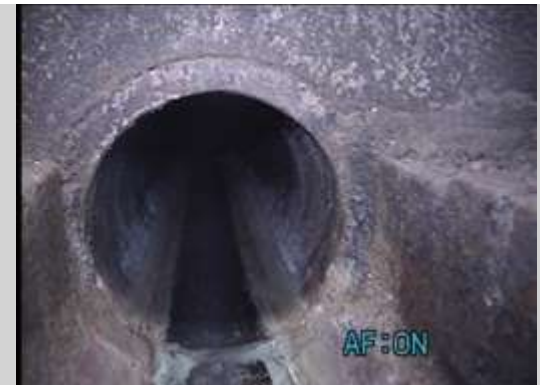
6 O'Clock Inflow

8 in. Circular Gravity Sewer
Pipe In @ 6 O'Clock

Pipe Height: **8.4** (in.) Rod and Bar (Angled)
Pipe Material: **Clay** ☐ Pipe Lined
Invert Depth: **8.71** (ft.) Flow Characteristics: **Slow**
Deposits: ☒ None ☐ Mud ☐ Sludge ☐ Debris ☐ Grease
Silt Depth: (in.) Deposits Extent:
Infiltration: **None** Pipe Seal Cond: **Sound**
